Ref.AUM/AI-171/Reason: 1317

**Sub: APPEAL towards probable reason of AI-171 Mishap on 12 Jun, 2025.**

**PROBABLE REASONS FOR AI-171 MISHAP AT AHMADABAD ON 12 JUN 2025.**

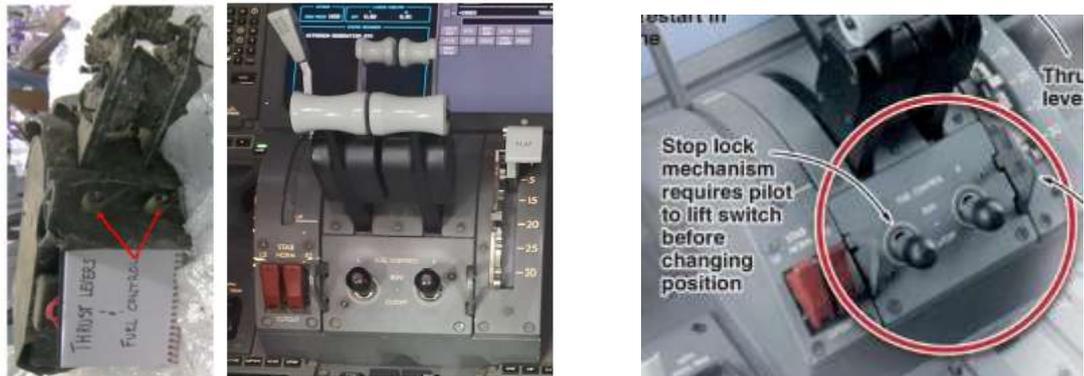
Figure 13 Thrust Lever Quadrant & Fuel Control Switch

- e) I raise concern over the quality of the spring-loaded switch design (spring tension, its stop mechanism) and also an issued FAA safety advisory (SAIB No. NM-18-33) that may have been overlooked by the airline authorities, requiring periodical inspection. The advisory FAA circular (SAIB) No. NM-18-33 on December 17, 2018, was taken lightly by the Air India maintenance department. Perhaps they could never anticipate such possible characteristics of the said small but heavy FCS's switches or its associated tiny 'Stops'. Complacency is devastating factor in aviation.
- f) This mishap could have also occurred due to design, location or condition of the airplane's Fuel Cutoff Switches (**FCSs**) or by reason of spurious/stray electrical signal output released by its associated avionics/software — if the pilots had not

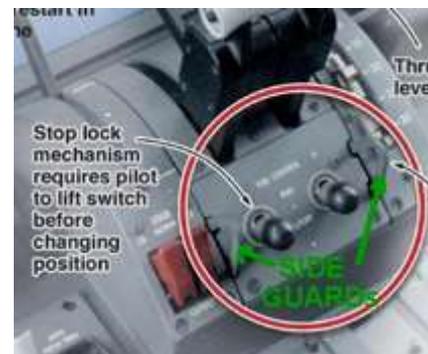
- b) Inclined base/surface: the FCUs are installed on an inclined surface just below the Throttle/TL Quadrant, in centre console/pedestal. This means that the FCUs base-panel is not parallel to the ground with airplane on ground, but inclined at about 40° (as could be understood by display). The location of the FCS fuel Switches on the Thrust lever or Throttle central console does not seem to be proper due to reason of the same being more vulnerable to impact/shock from below the Throttle quadrant area. The metal silver knob & sleeve of the switch may have disillusioned pilots by its adjacent located silver guards as shown above by Green arrows).

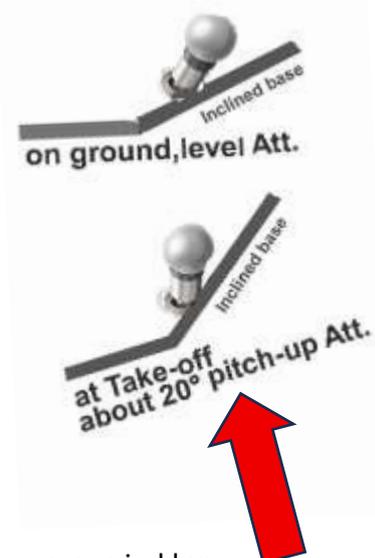
- c) At lift-off after VR, the pitch attitude of B-787 may be about 20° thereby resulting the FCSs inclination of switches increased to almost a more vertical position. Thereby, the said switches' heavy knob & sleeve got a push upward vertically, due to the Bang/Thud. The RED arrow is shown to indicate direction of effect of Bang's Air/Vibration in the vertical direction i.e. acting upward, so caused by the BANG/THUD from below the cockpit floor; thereby lifting the (FCSs) switches instantly upward i.e. off its respective seated position. And simultaneously; this occurrence event was also accompanied by:

- i. A rearward force due to the continuous acceleration of airplane. And,
- ii. Induced vibrations of normal Nose L/g. shudder once it leaves the ground at lift-off due gyroscopic effect, normally observed with all airplanes. And also;

- iii. due impact of airflow striking the area within the nose-wheel bay at pitch attitude of about 20°. *(Note: all AI generated FCSs are similar looking to the actual switches, shown here for illustration purpose only).*

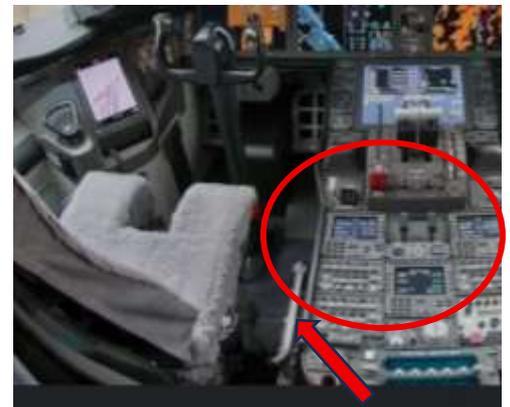
- iv. Moreover, pilot seat was also lifted off its notch on the railing track and it slid backward without pilot input, as a result of the strong vibrational effect of the Bang/Thud. The weight of Pilot's seat and the Pilot would be above 100 Kgs. The movable seat is installed on a **railing-track** (shown by Red arrow) mounted on the floor adjacent to the centre console, close to the FCSs. Under normal operation, the pilot gets in and sits on the seat then slides/moves it to right onto the railing and then forward. The **impact** of the explosion was so significant that it perhaps momentarily bent/twisted/jerked the floor area i.e. portion of the rack installed on cockpit-floor & area below the FCSs thereby knocking the seat off its notch in the railing resulting seat slide backward & **simultaneously the FCSs also popped-up**, perhaps. Major point of impact by the BANG was just below the area shown by RED circle, affecting the FCSs & pilot Seat Rack. The other pilot seat was unaffected by said Bang. (Google D/L photo of B787 cockpit)

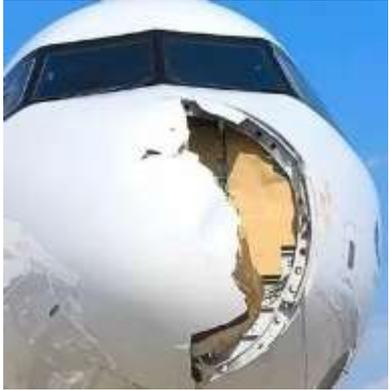
1. A **BIRD hit** on or around the Nose of the airplane could have rammed and shattered the nose-dome to strike the Cockpit **Bulkhead** with a Thud noise resulting vibrations. Once our airline's airplane had a bird-hit which shattered the nose-dome & cockpit bulkhead, broke inside into the cockpit by its impact and injured a pilot's foot. Recently, on 04 Aug. 2025 an Airbus airplane had a Bird-strike which shattered the nose dome of the airplane. <https://www.hindustantimes.com/world-news/chaos-on-paris-bound-flight-as-bird-strike-forces-emergency-landing-video-101754471857824.html>

- a) Such a strong strike could have caused sufficient sound or thud vibrations inside the cockpit to have immediately resulted both Start Switches to pop-out of their respective unguarded positions like a bullet upward and then slide backward to the CUTOFF position by moving/transiting over the flange/hump. Just like an inverted pendulum, free to move once popped-up; it's said movement got simultaneously aided by the 'acceleration' energy of the airplane i.e. a backward force during process of take-off, while accelerating towards 180 Kts., supplemented by the weight of knob+sleeve of FCSs thereby causing them to move unnoticed rapidly to their CUTOFF positions.

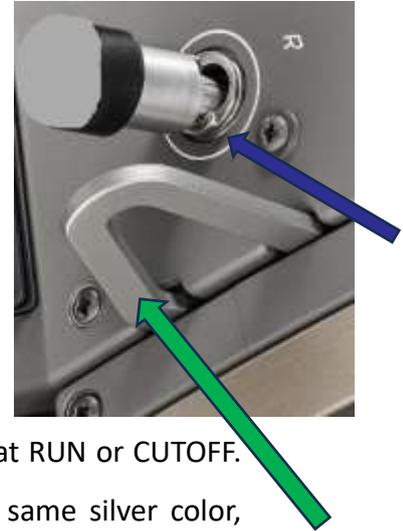
- c) **MAGNIFIED side view** AI generated photo of a Switch is shown to indicate the tiny Flange/Bump or hump i.e. a small metal **protrusion** which is only a **mechanical Stop** preventing movement of switches from sliding without lifting the silver KNOB and its associated Silver Sleeve, as seen on right side here, by a blue arrow. The sleeve has a spring mech. inside to permit lifting the entire switch to move over the BUMP and be released forward or backward onto its positions, at RUN or CUTOFF. Moreover, the proximity of the Side-Guard can be seen in almost same silver color, shown by Green arrow; which may have presented an optical illusion making FCSs be unnoticed about its movement or may have obstructed the view of pilots, psychologically. *(The above & below illustrations may or may not be similar to actual FCS. Shown here only for info. By help of AI assisted Apps. The B-787 variants' FCSs may have some minor differences.*

- d) **NOTE:** The said tiny **flange/bump** is not a lock, as being misleadingly alleged, but only a tiny flange as a metal 'Stop' incorporated just to prevent movement of switch without lifting the spring-loaded switch(s), by its designed tiny metal silver coloured protrusion,-

- i. It should have been more in height so that such an undesirable drag over it becomes more difficult.
- ii. The FCSs without the Switch-sleeve/knob **magnified photo** is also shown with blue arrows to indicate the Flange/hump/bump), which are only tiny mechanical STOPS.

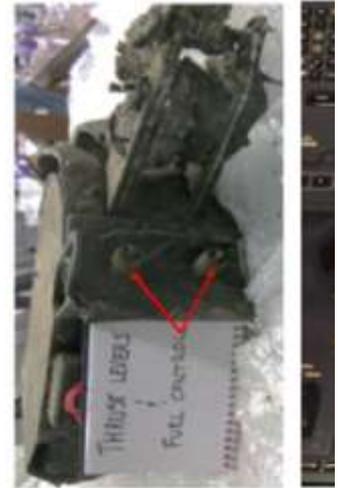
Figure 13 Thrust Lever

- f) The unexpected Bang/Thud's upward force accompanied by other aspects could have impacted upon the centre-console/below the Throttle Quadrant where FCS switches are located. The Bang/thud vibration was significant enough to simultaneously cause dislodging of pilot seat to jump-off its notch and slide backward, as reported. At this time the pilots could have been distracted by a BANG and also due to seat dislodging. Such unexpected simultaneous occurrence(s), at a most critical phase/time, may have prevented pilots noticing the FCUs movement. The AAIB report confirms the Throttle quadrant to be severely damaged, as shown, perhaps due to it being the main point of application of the **Bang/Thud-energy source** from directly below, acting upward, or in close proximity to the area below the Throttle quadrant, generating violent vibrations, as commonly seen due explosion caused by bursting of a cracker during festivals placed inside a container where the lid blows off instantly, however strong a lid be secured.
